Product Advisory

PA-664

Models Affected: L13i, LT, LTM, TL, and TM Aerials

SUBJECT: 4 - Function Stick Control (Assemblies 483417, 485144, 617812, and 483577)

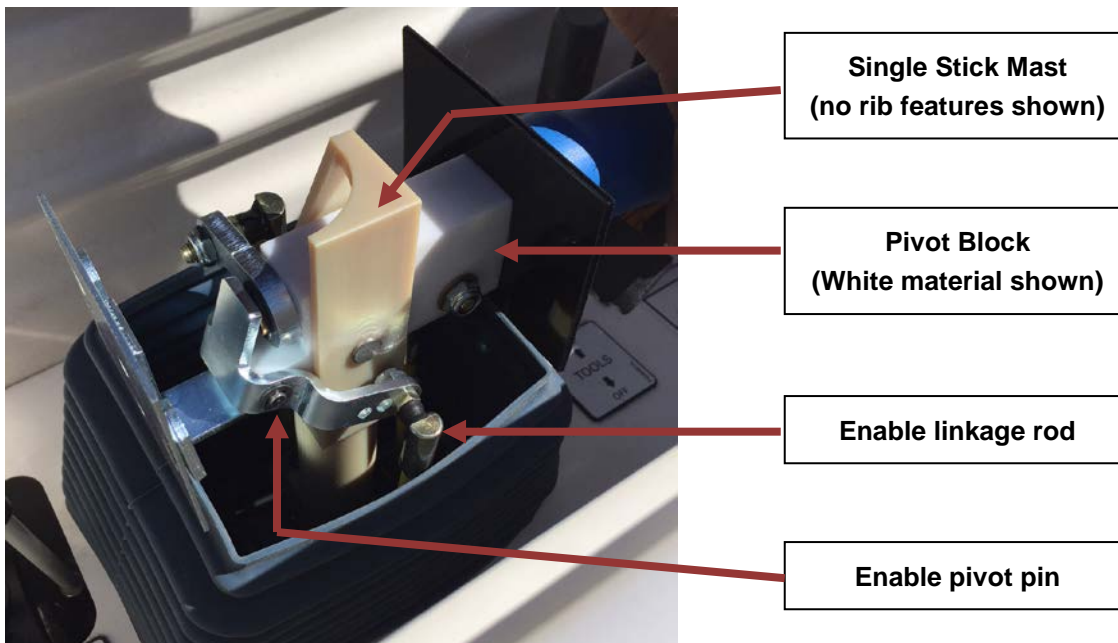
1. Remove the two plastic screws from the plastic cap, opposite side from the handle, of the single stick and remove the cap to gain access to the components shown in Figure 1. Inspect the Pivot Block and the Single Stick Mast for cracks.

Figure 1 - Cover removed to show components

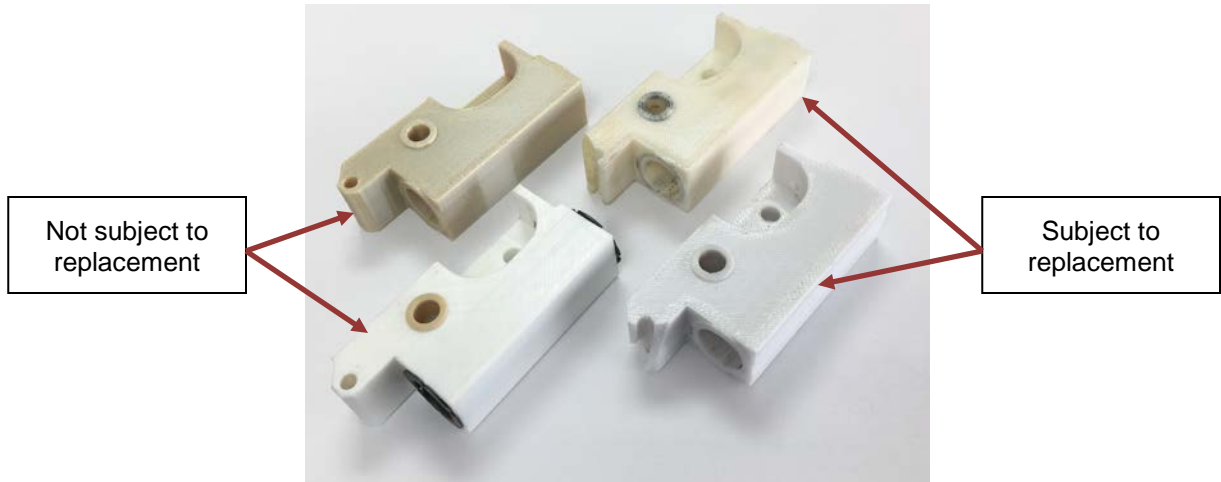
2. Inspect the pivot block material. Pivot blocks that are white in color, which have been manufactured with the bushing features as part of the base material, are subject to replacement. See figure 2. Pivot blocks that are tan in color or if the bushings are separate components from the pivot block (See figure 2a), are not subject to replacement.

Figure 2 – All possible pivot blocks

4. If components subject to replacement are found, contact TEREX Utilities Warranty, at 1-844-837-3948 to arrange for no charge replacement parts.
5. Inspect the Single Stick for proper operation.

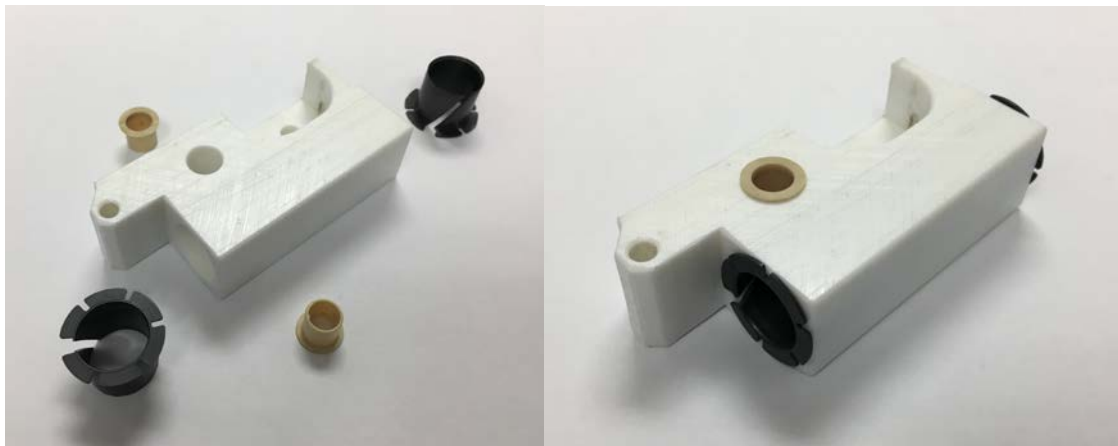
**Figure 2a – Pivot block with separate bushing components
(not subject to replacement)**

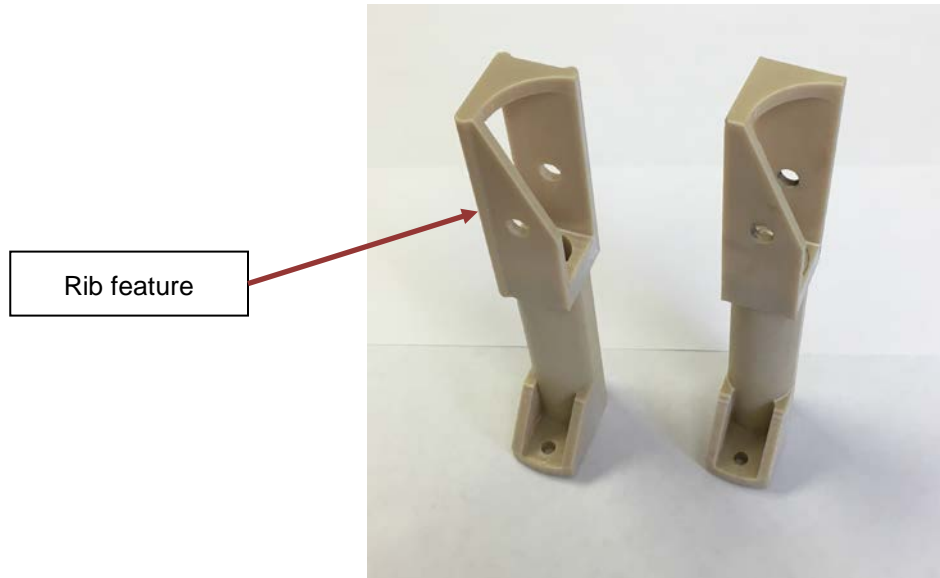
3. Inspect the single stick mast for the rib features shown in Figure 3 and Figure 4. Masts that do not have the reinforcement rib features are subject to replacement. Masts that have the reinforcement rib features or are black or yellow in color, as shown in Figure 5, are not subject to replacement.

Figure 3 – Ribbed mast on left and non-ribbed mast on right

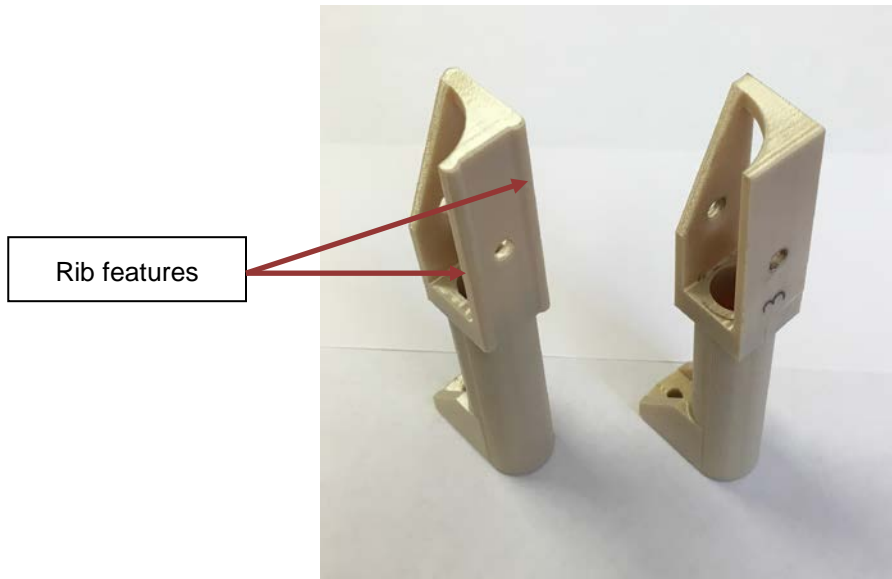
Figure 4 – Ribbed mast on left and non-ribbed mast on right

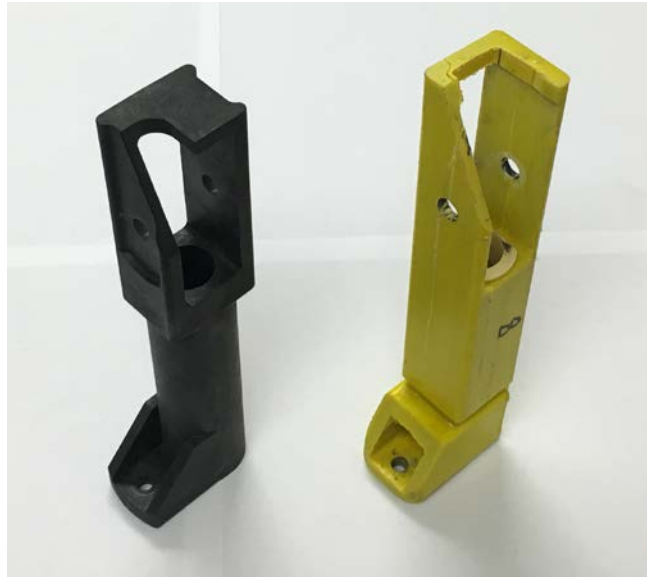
**Figure 5 – Black colored mast on left and Yellow colored mast right
(not subject to replacement)**
