# ADJUSTTMENTS FOR RADIAL OUTRIGGERS CREEPING DOWN NO.115

SERVICE CALL: ADJUSTMENTS FOR RADIAL OUTRIGGERS CREEPING DOWN

MODEL(S): ALL TEREX MODELS USING THE CYLINDER 603020 ON RADIAL OUTRIGGERS

TECH TIP 115 | RELEASED 04.21.2023 | VERSION 1.0 ©TEREX UTILITIES. ALL RIGHTS RESERVED

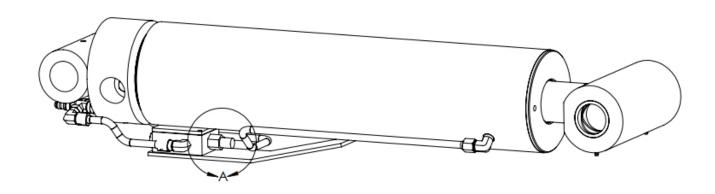
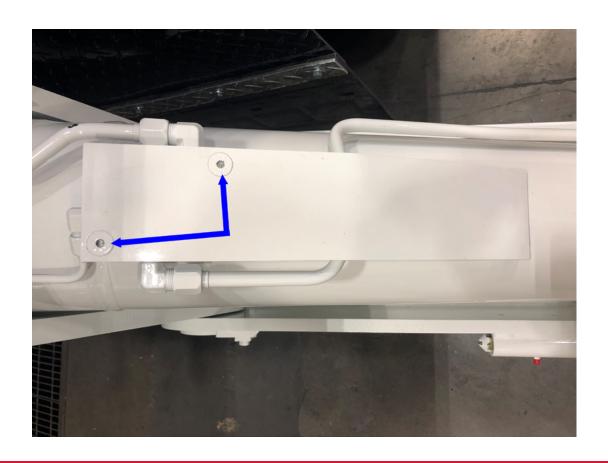
This adjustment can be made for radial outriggers that drift slightly due to a latch that is out of adjustment or from thermal expansion when parked overnight in the stowed position.

Lower the radial outriggers and remove the guard to gain access to the holding valve (See A in the drawing below).

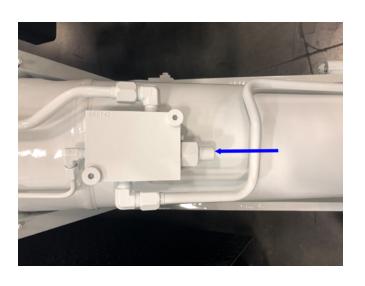
The holding valve is set at a 3700 psi crack pressure and is rated at 3000 psi holding pressure.

Remove the cap to adjust the holding valve setting.
