A popping or cracking noise that appears to be coming from the mast or pedestal area

Optima HR, Optima HRX, Optima TC, Optima TCX

Introduction

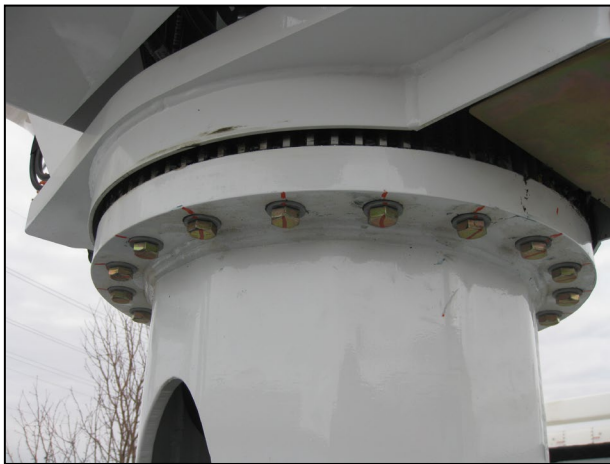
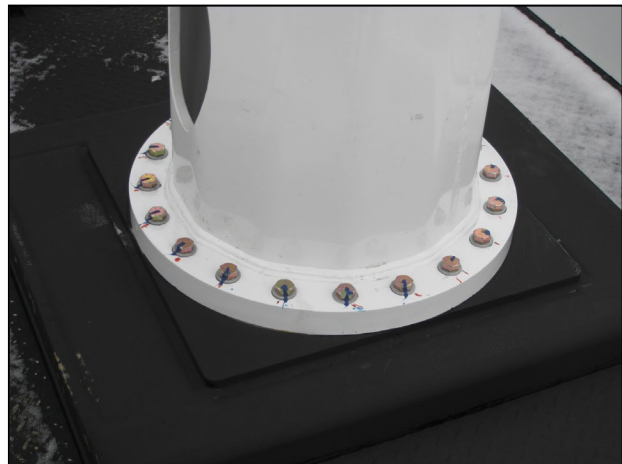
Figure 1

The noise repaired by this tech tip will be a popping or cracking noise that appears to be coming from the mast and/or pedestal area. The noise will be sharp in sound and will not be dull or subdued. It can typically be heard standing next to or at the back of the unit. The most common position for the noise to happen is at the end of the lower boom stroke, either up or down, with the upper boom in any position.

The noise is created by minor imperfections in the bearing/pedestal/subframe mounting surfaces and friction on the surfaces as weight is transferred while moving the boom. Very few units have imperfections that will cause this to happen and adding a spacer coated in anti-seize will separate and reduce friction between the surfaces that cause the noise.

When the noise is duplicated, have someone listen near the joint of the rotation bearing to the pedestal and the pedestal to the subframe (Figure 1 and 2). The noise should be loud at one or both locations and will present as a cracking or popping sound.

This noise can be eliminated by installing spacers between the bearing/pedestal and pedestal/subframe joints. The spacer shown in Figure 3 is part number: 404285. Two of these spacers are required. Rotation bearing to pedestal and pedestal to subframe bolts and washers will also be replaced when the spacers are installed.
