TEREX®

REPLACING A WORM GEAR ROTATION GEARBOX END CAP SEAL

NO. 160

MODEL(S):
C4000 AND C5000

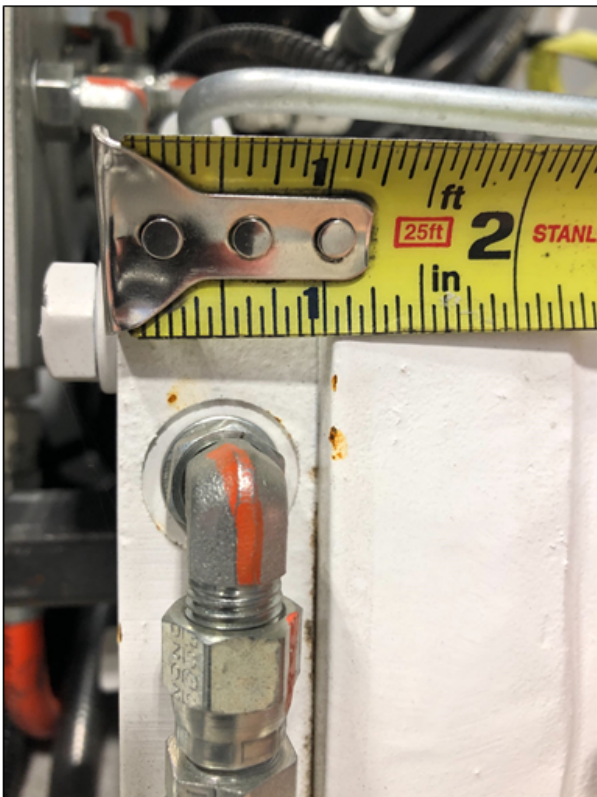
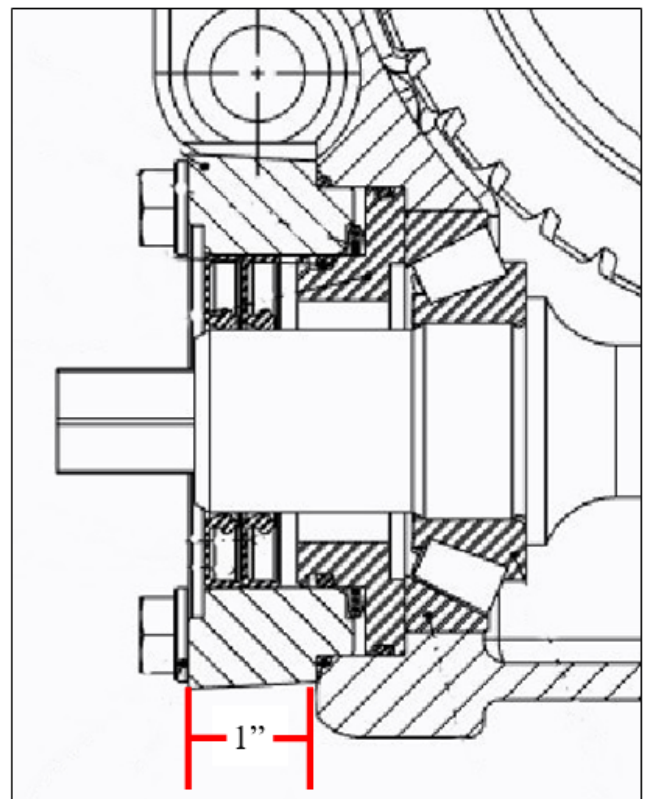
A second seal can be installed in an older gearbox if it is equipped with a 1-inch endcap.

The photo and drawing below show where to measure to confirm the dimension.

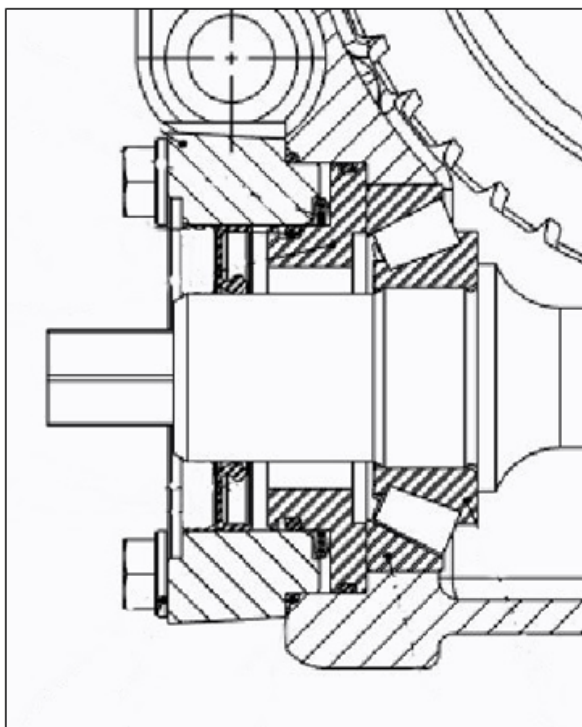
Single Seal

The drawings below show the gearbox endcap with the single seal and the double seal.

If installing only one seal drive the seal to a depth of 1/4 inch below the outside surface of the endplate. Verify that the seal is recessed evenly around the entire bore.

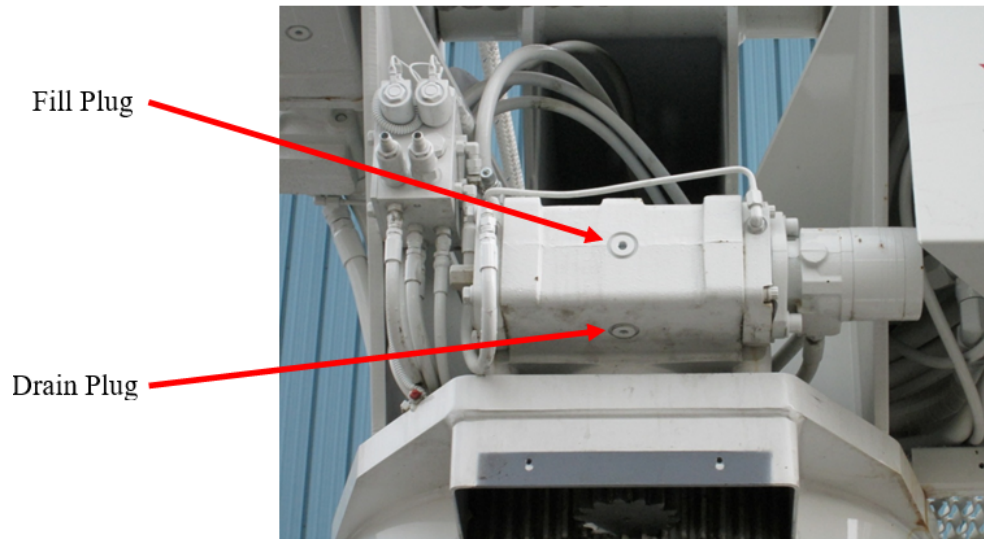
Remove the fill plug (as shown in the photo below) on the back side of the gearbox and verify that it is not filled with hydraulic oil. Leave the drain plug out.

If the gearbox is filled with hydraulic oil, the cause must be repaired prior to replacing the output seal.

Drain the gearbox completely by removing the drain plug (as shown in the photo above) on the bottom of the gearbox. Reinstall the drain plug once the gearbox is empty.

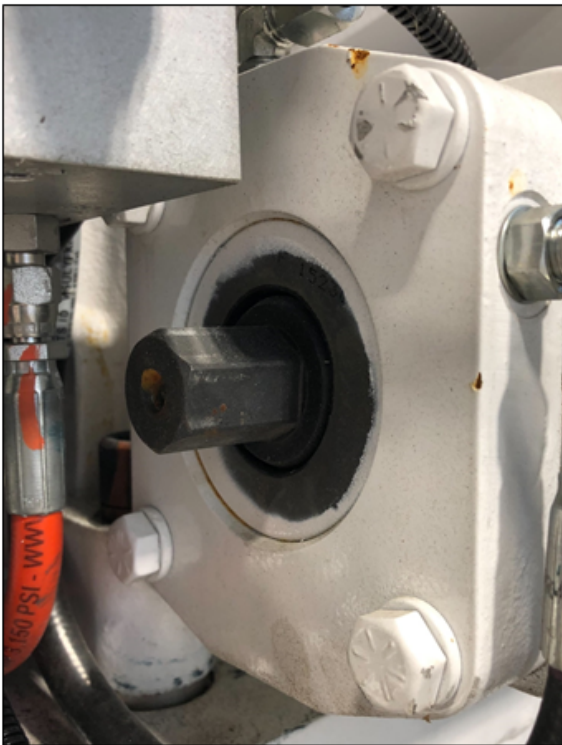
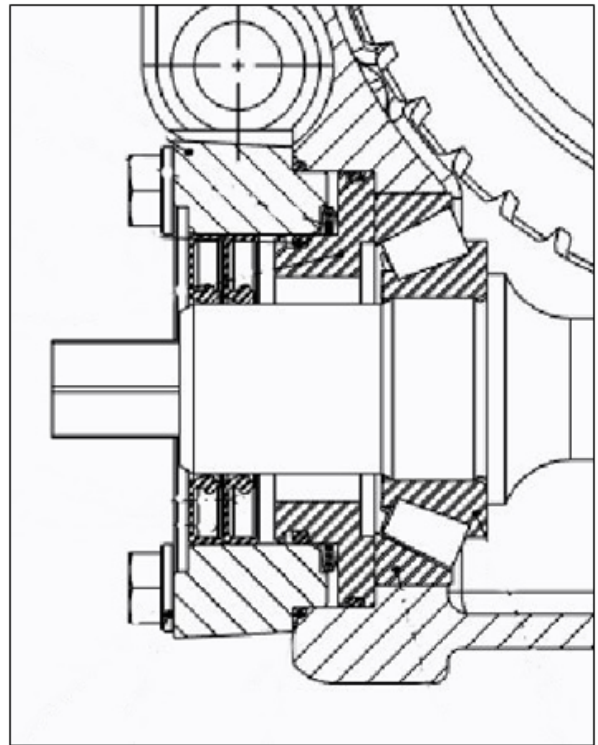
The drawing below shows both seals installed in the endcap recessed approximately 1/8-inch face of the endplate. The photo shows the depth of the finished seal installation.

Install the second seal recessed approximately 1/8 inch from the face of the endplate. Both seals will be installed the same direction.
