## **TRAC Case Study: Restoring Screen Performance Through Accurate Vibration Analysis**

**Equipment:** Cedarapids® TSV Series, 8'x20'- 3 Deck (Simplicity® Model ES Series)

**Location:** Wendling Quarries – Cedar Rapids, IA - Q4 2025

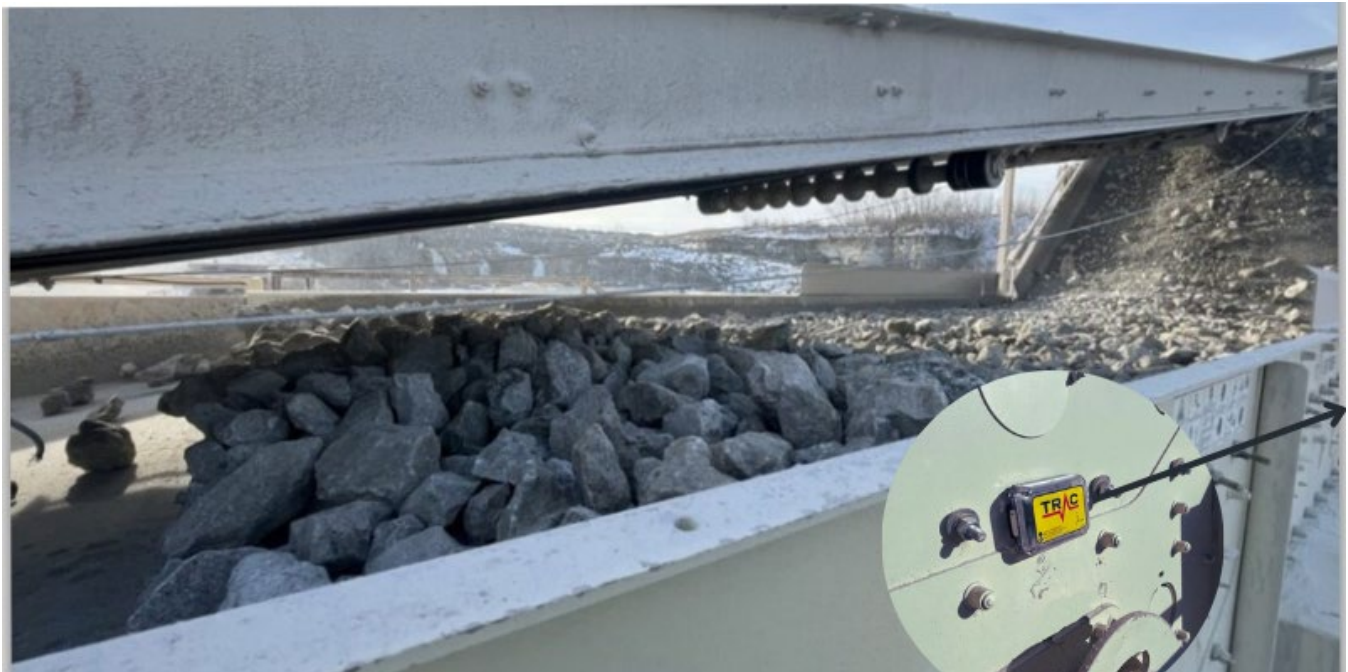
The TRAC data showed that symmetric screen motion, which means the left and right sides were moving together at the same time and in the same direction. However, the G-forces were significantly lower than the expected 7 Gs. Further review of the data revealed the screen was operating at approximately 700 RPM, well below its normal operating speed of 830 RPM.

The low operating speed resulted in lower G-forces preventing near-size material from moving efficiently across the discharge end of the screen. This explained why material was hanging up despite the screen appearing to operate normally.

TRAC clearly pointed out the speed-related issue pointing the engineer to inspect the screen drive. The inspection revealed a broken spring in the V-belt tensioner causing the V-belt to slip on the pulley and therefore unable to maintain proper operating speed. Without TRAC's analyzer software, it would have been difficult to identify this issue without accurate vibration and speed data.

Material collecting at the end of discharge end, when it should be flowing freely.

**Cause:** V-belt has a broken spring causing the V-belt to slip on the pulley and therefore unable to maintain proper speed.

After replacing the V-belt tensioner and V-belt, the screen returned to its optimal operating speed, material flow normalized and the customer was back to full production.
