Service Call:

Inspecting Fiberglass Leveling Rods

All Units with Fiberglass Leveling Rods

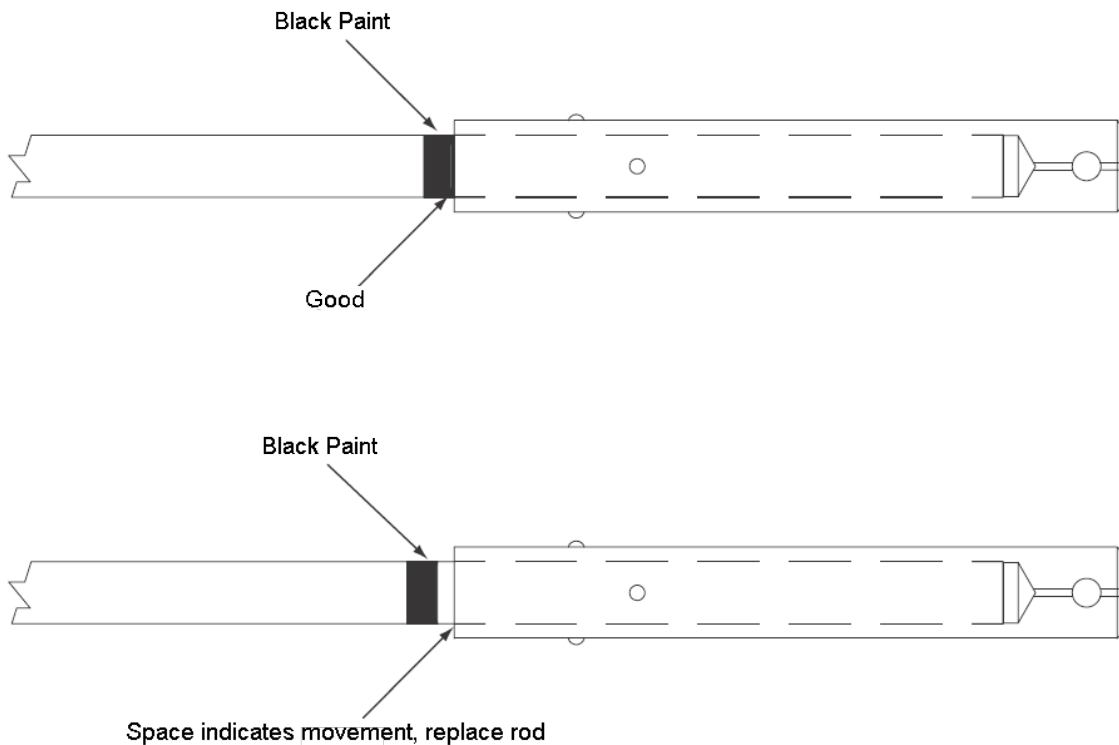
Check the terminal end and inspect the area bonded on the ends. The smaller 1/2" rods with the roll pins on the ends will have a black paint mark against the terminal end.

If there is no gap between the terminal end and the black paint marker and the roll pins are in place and have not sheared, then the rods may be placed back in service. This style of rod is common in the XT series.

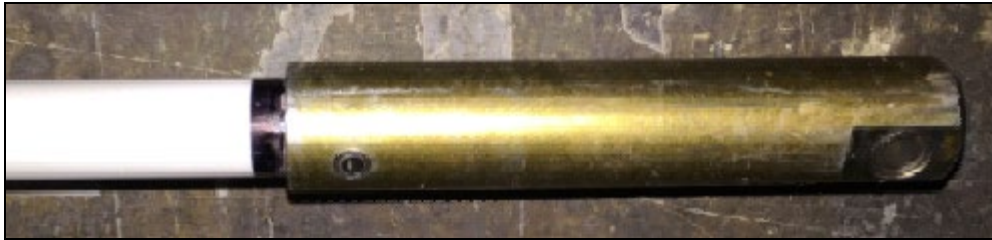
These are examples of the latest rods found in the XT Pro series. Note that they are in good condition and have not separated from the terminal end.

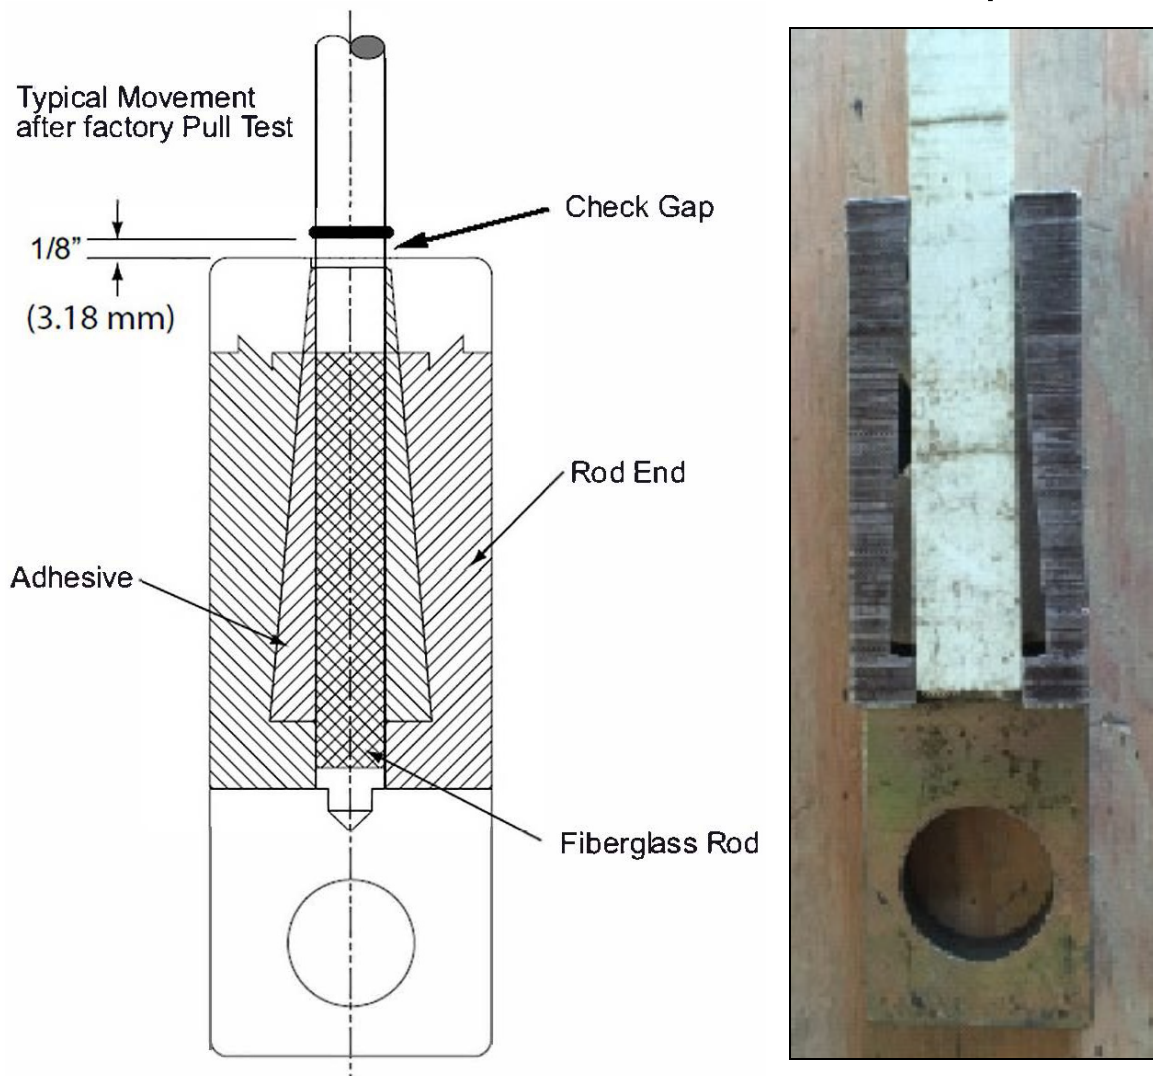
Gap between O-ring and Terminal

Units equipped with platform rotation have a wedge-shaped cavity. Each rod is pull tested after curing and will typically move 1/8". If the gap between the O-ring and the terminal is larger than 1/8", then further evaluation is needed to determine if the rod must be replaced.

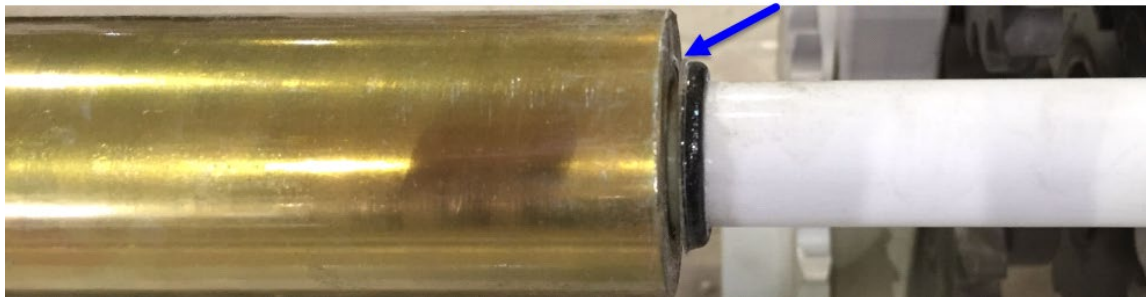
The picture above is an example of what the terminal end looks like on the heavy leveling rods found on any unit with platform rotate produced on or before November 2016.

On these style leveling rods, a 1/8 inch gap is normal between the O-ring and the terminal end. If a gap is larger than 1/8", further evaluation is needed to determine if the rod must be replaced.

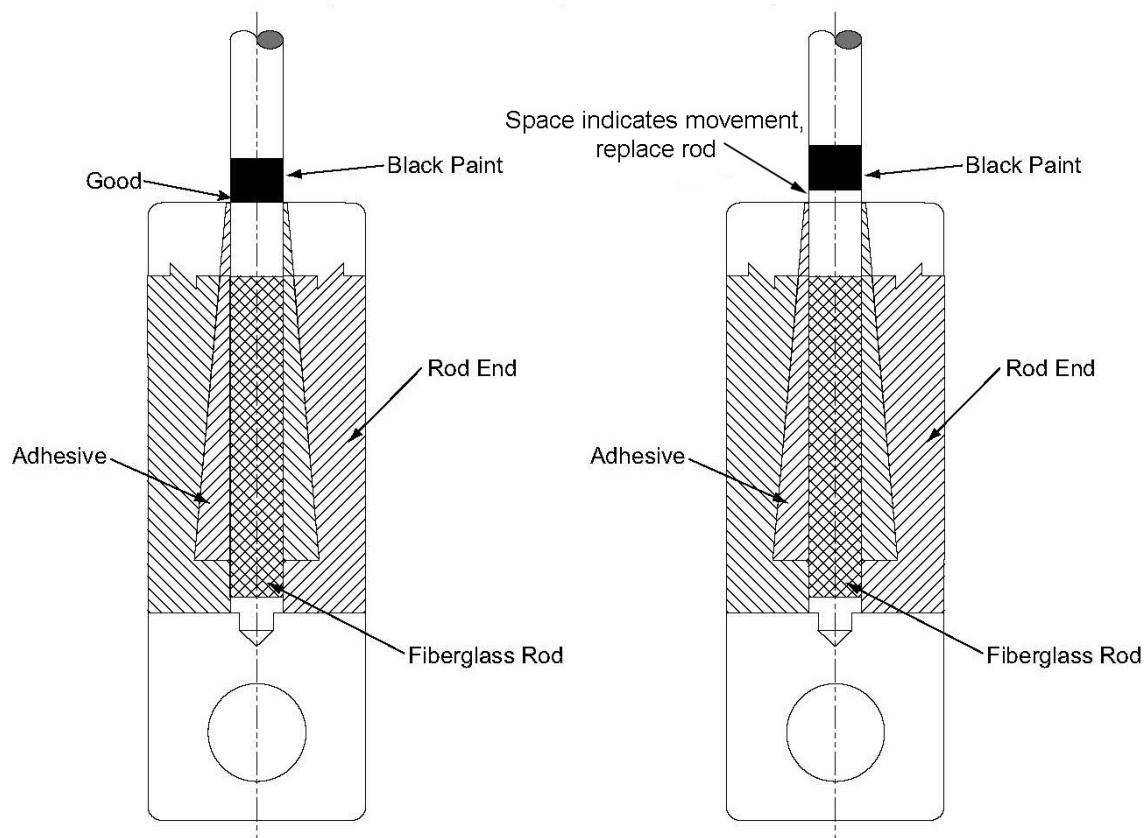
Note: Starting in November of 2016, a change has been made to the visual aid for detecting movement in the leveling rod assembly between the insulated rod and rod end. The O-ring has been replaced by a black paint mark at the terminal that is applied after the pull test.

If there is no gap between the terminal end and the marker, then the rods may be placed back in service. If a gap exists, the rod must be replaced.
