TECH TIP 87 | RELEASED 09.21.2022 | VERSION 1.0 ©TEREX UTILITIES. ALL RIGHTS RESERVED

CONTENTS TECH TIP#87

INTRODUCTION

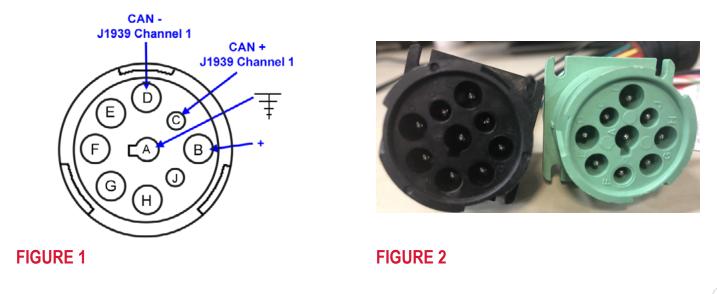
This Tech-tip will guide you through checking the resistance and voltage in the J1939 datalink. J1939 is a high-speed vehicle data link that can communicate at either 250kb/s or 500kb/s. The datalink consists of three wires: yellow is CAN +, green is CAN - and Shield is connected to ground.

Note: Black connecter primary CAN is 250K, the green connector primary CAN is 500K. Figure 2

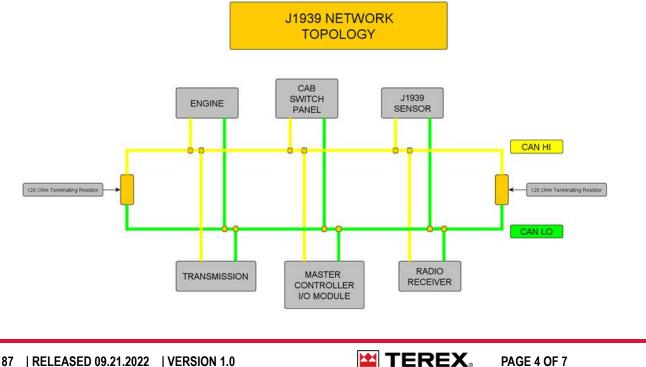
Two 120 Ω resistors are required to complete the J1939 network topology.

Note: It is important to use twisted pair wires to evenly distribute electrical static between CAN + and CAN -.

Turn the ignition key off and disconnect the batteries. Set the multimeter to ohms and place the leads between CAN + (Pin C) and CAN - (Pin D).

$60\Omega \pm 6\Omega$	The J1939 datalink is good. Go to step 2.
120Ω ± 12Ω	 One of the terminating resisters is missing. One of the terminating resisters is open. Open circuit between the termination resisters.
40Ω ± 4Ω	Three Terminating resisters have been installed. One must be removed.
0Ω to 5Ω	CAN + and CAN - are shorted within the system
> 1000 Ω	 Most likely cause is an open circuit between the diagnostic connector and the J1939 backbone. Both terminating resisters are open or missing.
Any Other Reading	 Incorrect terminating resister resistance. Poor or corroded connections. Short circuit to ground or open circuit in the datalink.
