TEREX®

REPLACING A WORM GEAR ROTATION GEARBOX END CAP SEAL

NO. 160

MODEL(S):
C4000 AND C5000

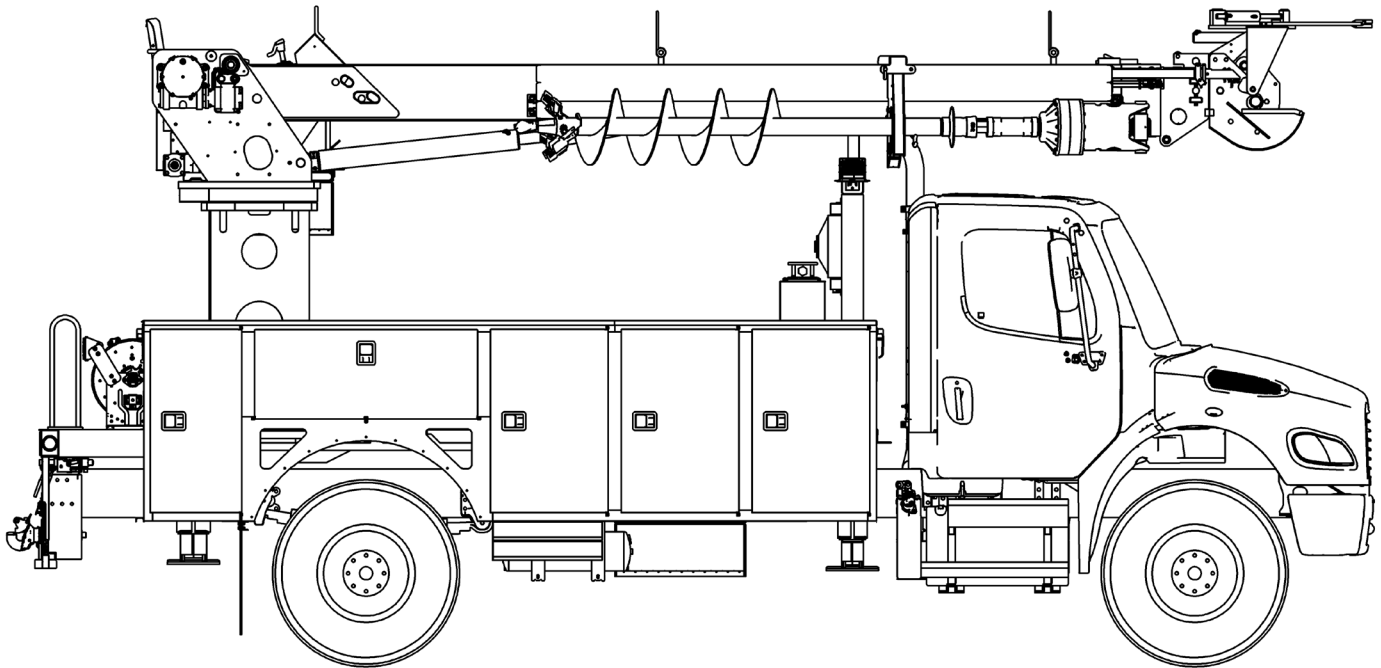
| Leaking worm gear rotation gearbox end cap

A leaking worm gear rotation gearbox end cap seal can be caused by the following:

- Improper storage of the digger derrick into the boom rest, creating a side load on the rotation gearbox
- A hydraulic leak from the motor or HOP system that fills the gearbox with hydraulic oil
- Overfilling the gearbox with gear oil
- Over greasing the top pinion shaft bushing

Once the seal begins to leak, replacement will be required.

Beginning mid-year 2021, a production change was made to add a second seal to the endcap for additional leak protection.

If the gearbox is filled with hydraulic oil, the cause must be repaired prior to replacing the output seal.

Refill the gearbox with Mobilux EP-023 or equivalent gear lube. Fill the gearbox so that the gear lube level is approximately 1/8" below the fill plug opening. This will keep the oil level below the lip of the seal and reduce the chance of future leaks.

Test the rotation gearbox and check for leaks before returning to service.
