IC-100 Case Study

Machine: **IC-100**
Location: Co. Tyrone, N. Ireland
Material type: Glass from blue bin waste (0-100mm)
Machine spec: Primary = 60mm
Secondary = 20mm
4 High blowbar configuration
Martensitic Blow Bars
Rotor Speed: 799 RPM, Tip Speed = 39.6 m/s
Output: **60-80mtph (66–88 US tph)**
Blowbar Wear: 17mm after 2200 tonnes

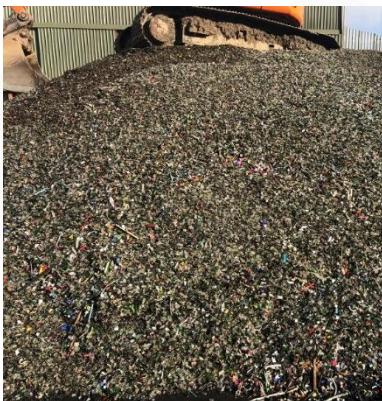
Feed Material

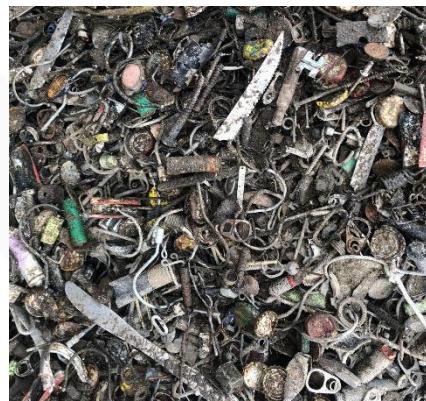
Metal removed by magnet

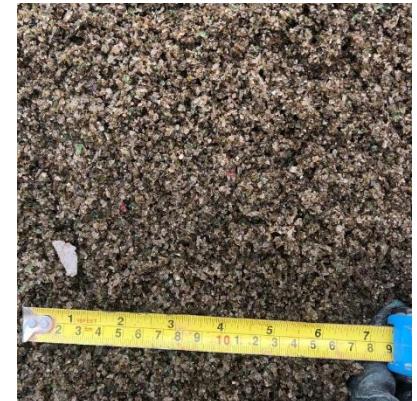
0-10mm Final Product
