# IC-100 Case Study

Machine: **IC-100**  
Location: Co. Tyrone, N. Ireland  
Material type: Glass from blue bin waste (0-100mm)  
Machine spec: Primary = 60mm  
Secondary = 20mm  
4 High blowbar configuration  
Martensitic Blow Bars  
Rotor Speed: 799 RPM, Tip Speed = 39.6 m/s  
Output: **60-80mtph (66-88 US tph)**  
Blowbar Wear: 17mm after 2200 tonnes

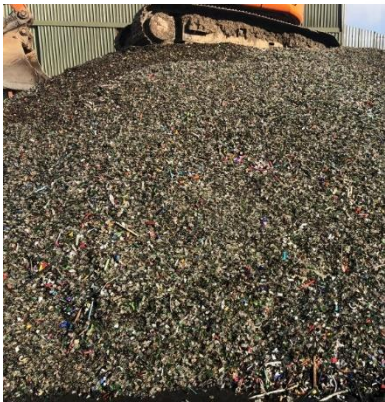
Feed Material

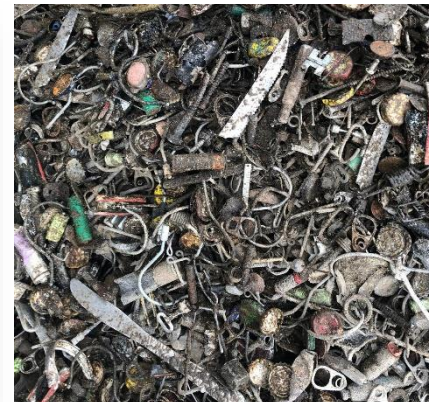
Metal removed by magnet

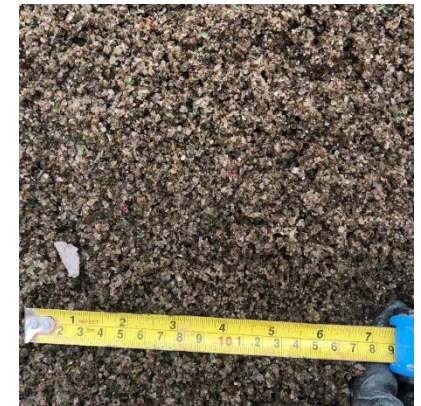
0-10mm Final Product
